Lake Eureka Spillway Investigation

April 18, 2024

Curtis Janssen, P.E.
Eocene Environmental Group

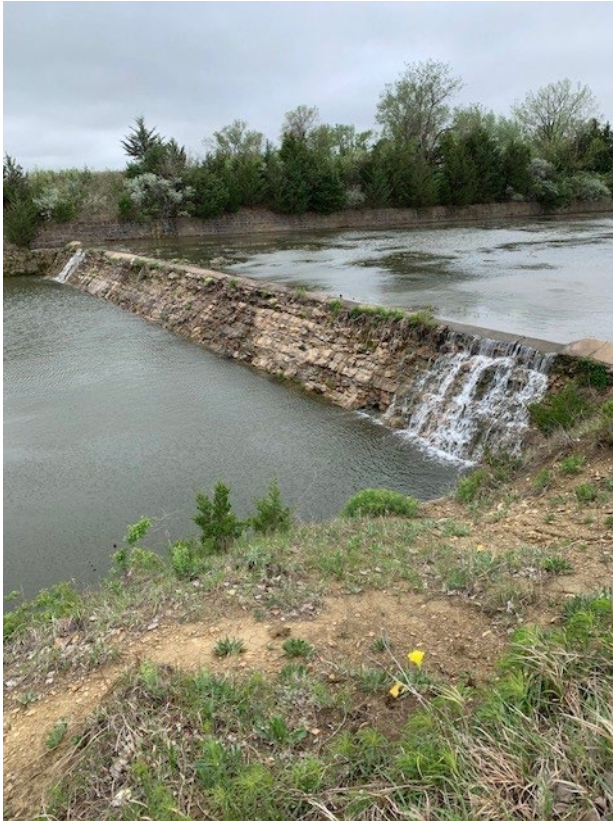
The area under investigation was the exposed rock drop-off in the upper section of the spillway as shown in Pic.1 and Pic. 2 - Appendix. More precisely, lake residents observed water flowing in various areas along the base of the rock drop-off. The flow is most observed during dry weather periods. During the on-site investigation, one such area was observed immediately next to the water shown flowing over the spillway crest as shown in Pic. 3 – Appendix. No similar areas were observed at the time. In discussion with the individuals on site, other areas have been observed when the pool at the base of the drop-off is lower and more of the rock drop-off is exposed.

No visible signs of degradation or deterioration were noted along the length of the drop-off or at the specific area noted at the base of the drop-off. The concrete cap or weir along the top of the drop-off also appeared to be in good condition and functioning as designed. The weir serves as the control section of the water level in the reservoir as water exits the lake. Overall, no unusual conditions were observed along the area of concern during the on-site investigation.

Pic. 1 – Spillway drop-off.

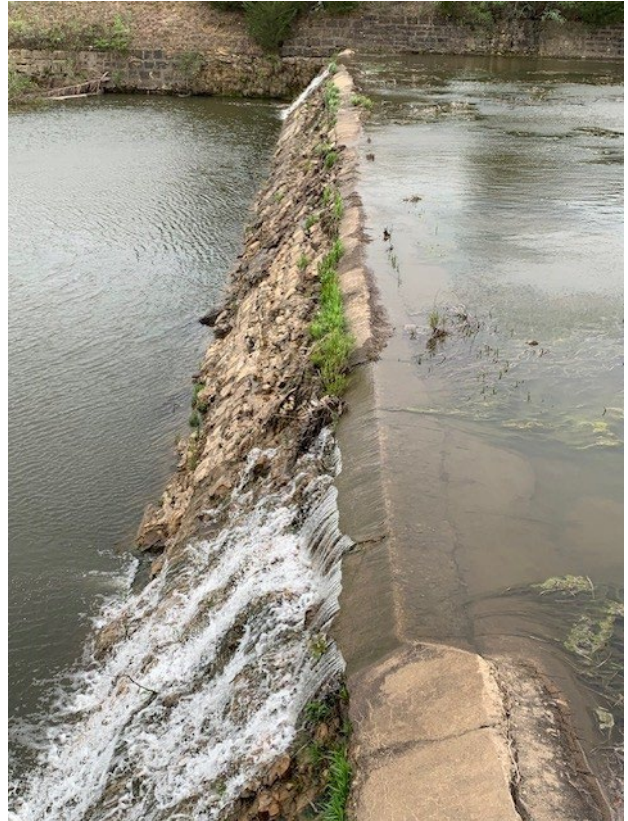
Pic. 2 – Spillway drop-off.

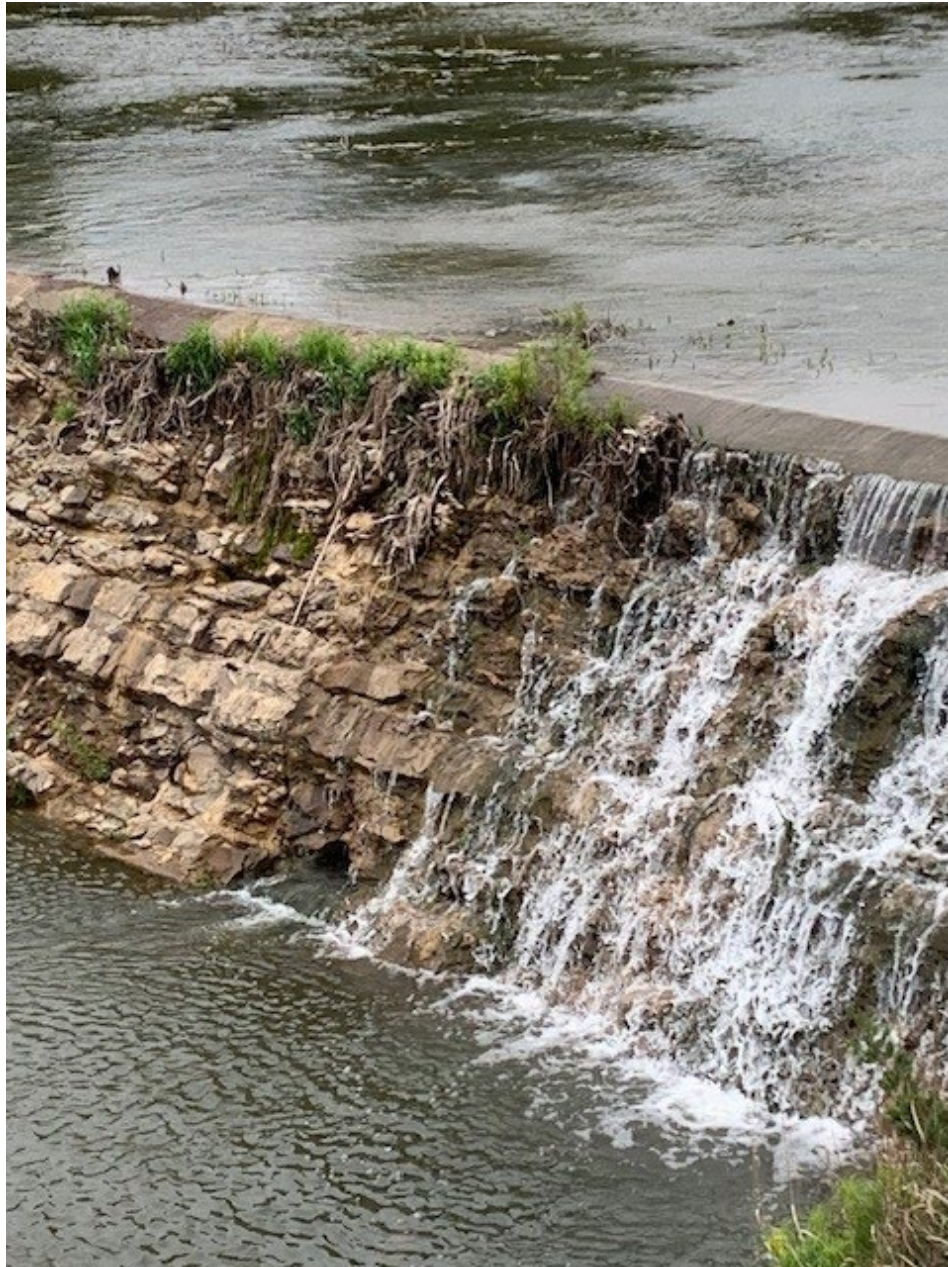
The observation of water flowing from areas at the base of the spillway drop-off directly corresponds to drainpipes originally designed in these locations. These areas are not detrimental to the spillway, but rather are an important component to the design of the structure to relieve potential hydraulic pressure within the spillway. Visible observation from the on-site investigation reveals the condition of the spillway drop-off and concrete cap / weir to be in good condition and functioning as designed.

The amount of flow from these areas should not significantly lower the pool level in the lake. The capacity of flow from these areas is minimal compared to the potential amount of inflow coming into the reservoir. The drainage area above the reservoir is 9,835 acres or 15.4 square miles. This size of drainage area is large enough that even during times of drought or limited rainfall, the amount of base-flow or underground flow into the reservoir should far exceed the amount of flow lost from these areas of concern.

Pic. 3 – Area of concern, shown at base of of the spillway as a black “hole”; immediately left of cascading water in picture.

Eocene concludes no repair or modification to the spillway is necessary to further address the concern of this investigation.

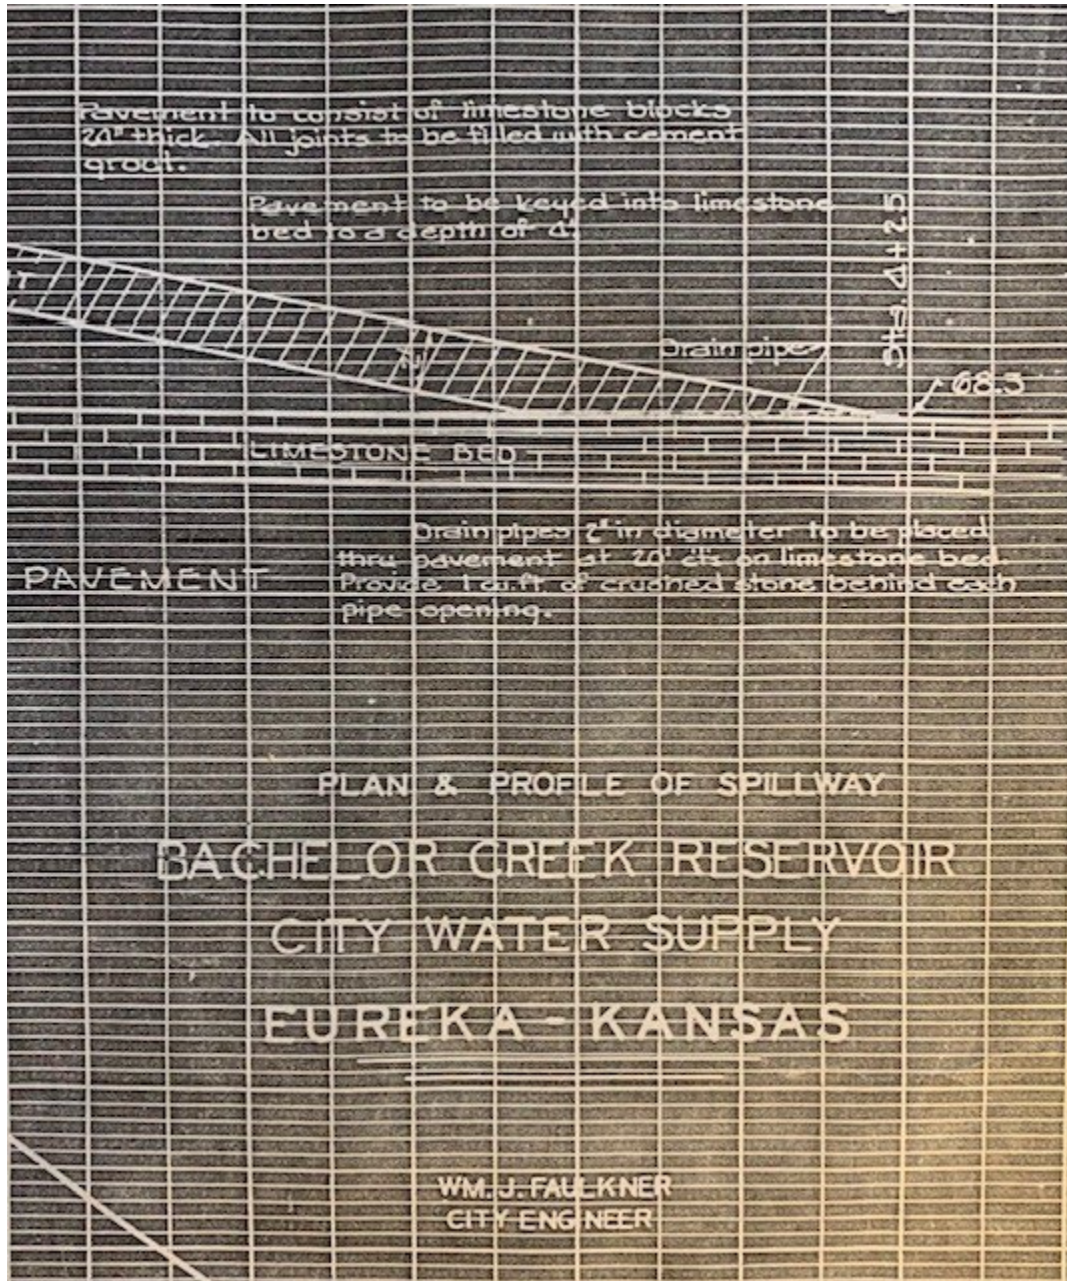
Details of the spillway shown on sheet 6 of the original plans, reveal a construction note stating the following:

“Drainpipes 2” in diameter to be placed thru pavement at 20’ cts (centers) on limestone bed. Provide 1 cu.ft. of crushed stone behind each pipe opening.”

The detail associated with this note (Pic. 4 – Appendix) shows the drainpipes to be placed on top of the limestone bed at the base of the spillway. The elevation and placement of these drainpipes directly correspond to the areas of concern noted by the lake residents. The present drop-off of the spillway is much steeper than the original design, however, it appears some type of drainpipes were installed at the base of the spillway either during original construction or

during a later modification. Such pipes were installed to safely relieve hydraulic pressure that may build up within the rock.

Pic. 4 – Construction note referencing drainpipes at base of spillway; taken from original 1935 plans.
